# RECONNAISSANCE SITE INVESTIGATION OF THE PROPOSED BARBERTON CROSSINGS DEVELOPMENT

December 2007

**Re: RECONNAISSANCE SITE INVESTIGATION**  
**BARBERTON CROSSINGS – TAUTONI PROPERTY DEVELOPMENT**

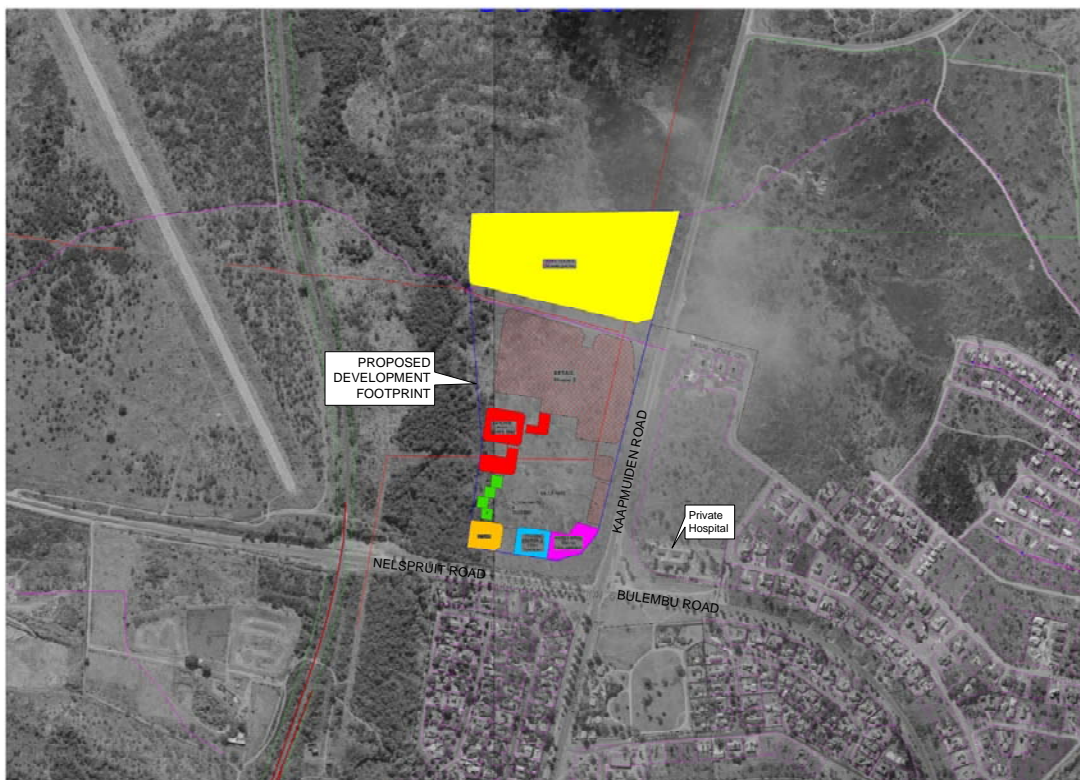
Figure 2 Site Plan

The general geology of the site was mapped using the limited exposures occurring in the borrow pits/quarries and as rock outcrops on surface. Representative profiles were logged in shallow cuttings as well as a number of auger points. The approximate positions of these exposures and auger holes are indicated on the Site Plan, Figure 2 and the profile descriptions are included in Appendix 1.
